TEST REPORT

Full scale bushfire external wall test of a framed wall system in accordance with AS1530.8.1-2007.

2581501.1

NRG Building Systems
Factory 4, 32-38 Dover Drive,
West Burleigh
QLD, 4220, Australia.

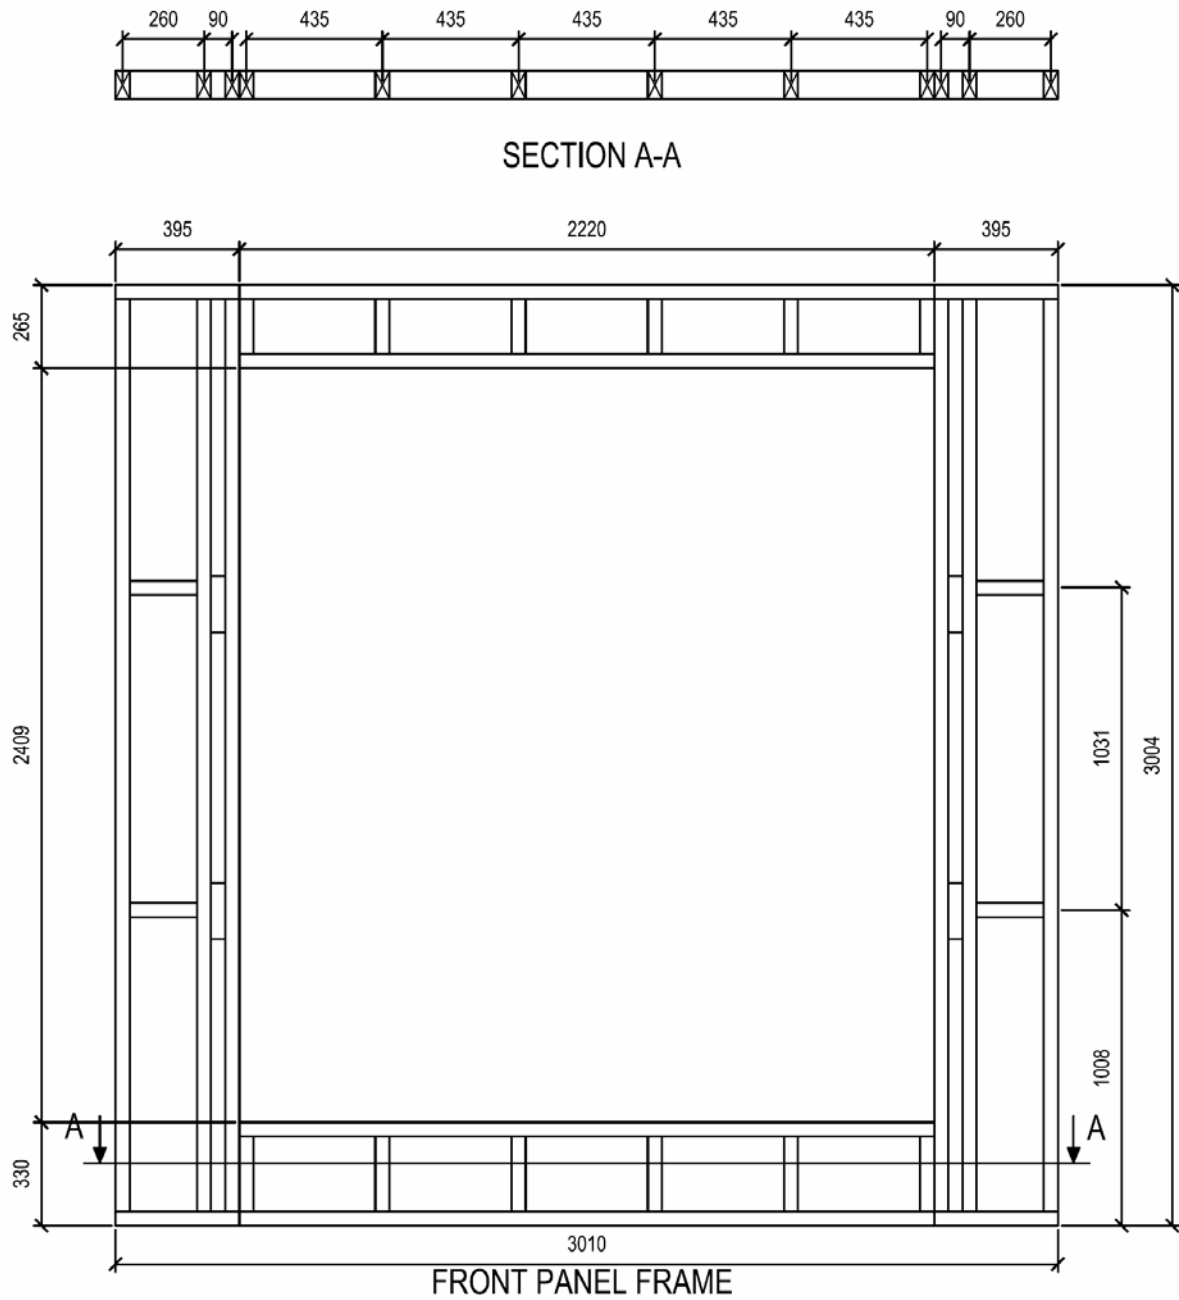
Figure A1.1: Front frame elevation.

The wall system consisted of two 90×45 timber stud frames, the central frame offset 250mm back incorporating a 800mm × 800mm timber reveal window. The unexposed side was faced with 10mm Gyprock plasterboard while the exposed side had a 10mm Rockcote PM100 QRender over 73mm Greenboard™ foam cladding. Further details are provided in Figures A1.1 to A1.4 and the Schedule of Components.

Framing		
12	Product	90x45 MGP10 Radiata Pine
	Density	435 kg/m ³ (measured)
	Moisture	Average of 9.7% (measured)
	Location and spacing	Refer to figures A1.1 and A1.2 for frame details.
Eave/Sill		
13	Eave Cladding	6mm Gyprock Fibre-cement sheet
14	Sill Cladding	13mm Gyprock Fyrcheck Plasterboard
15	Sill Cladding	6mm Gyprock Fibre-cement sheet

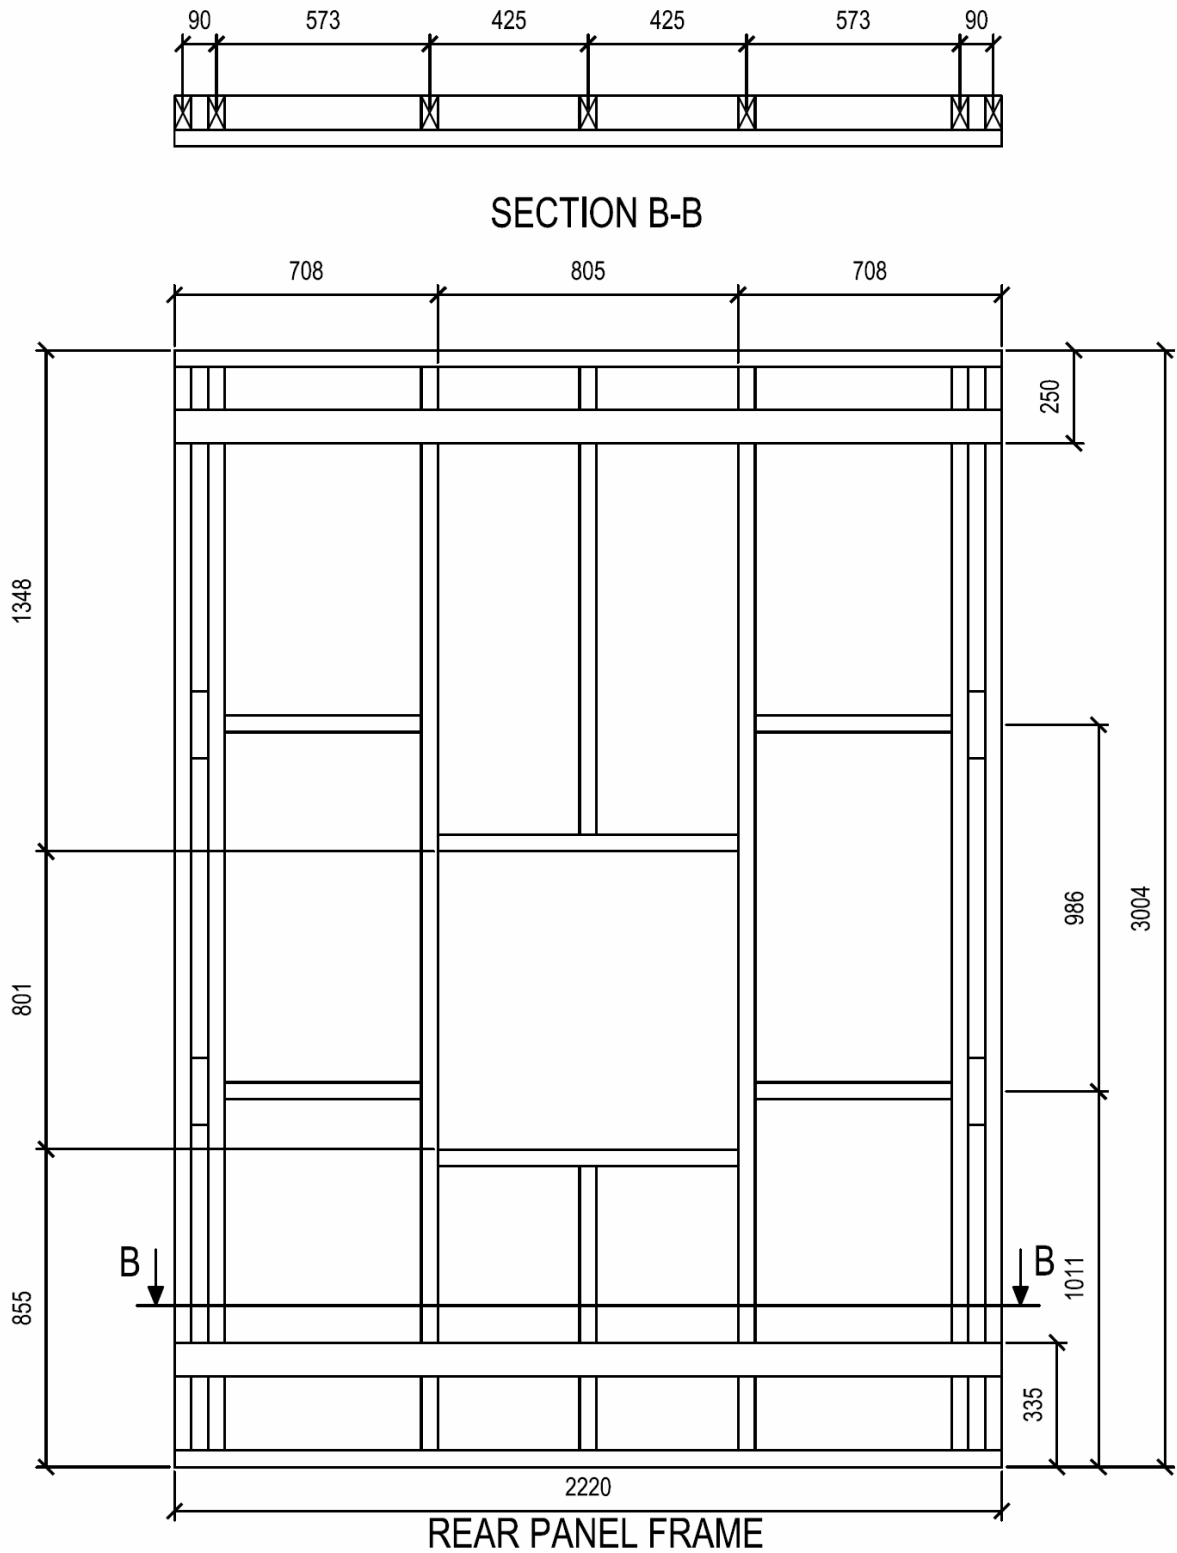
Figure A1.2: Rear frame elevation

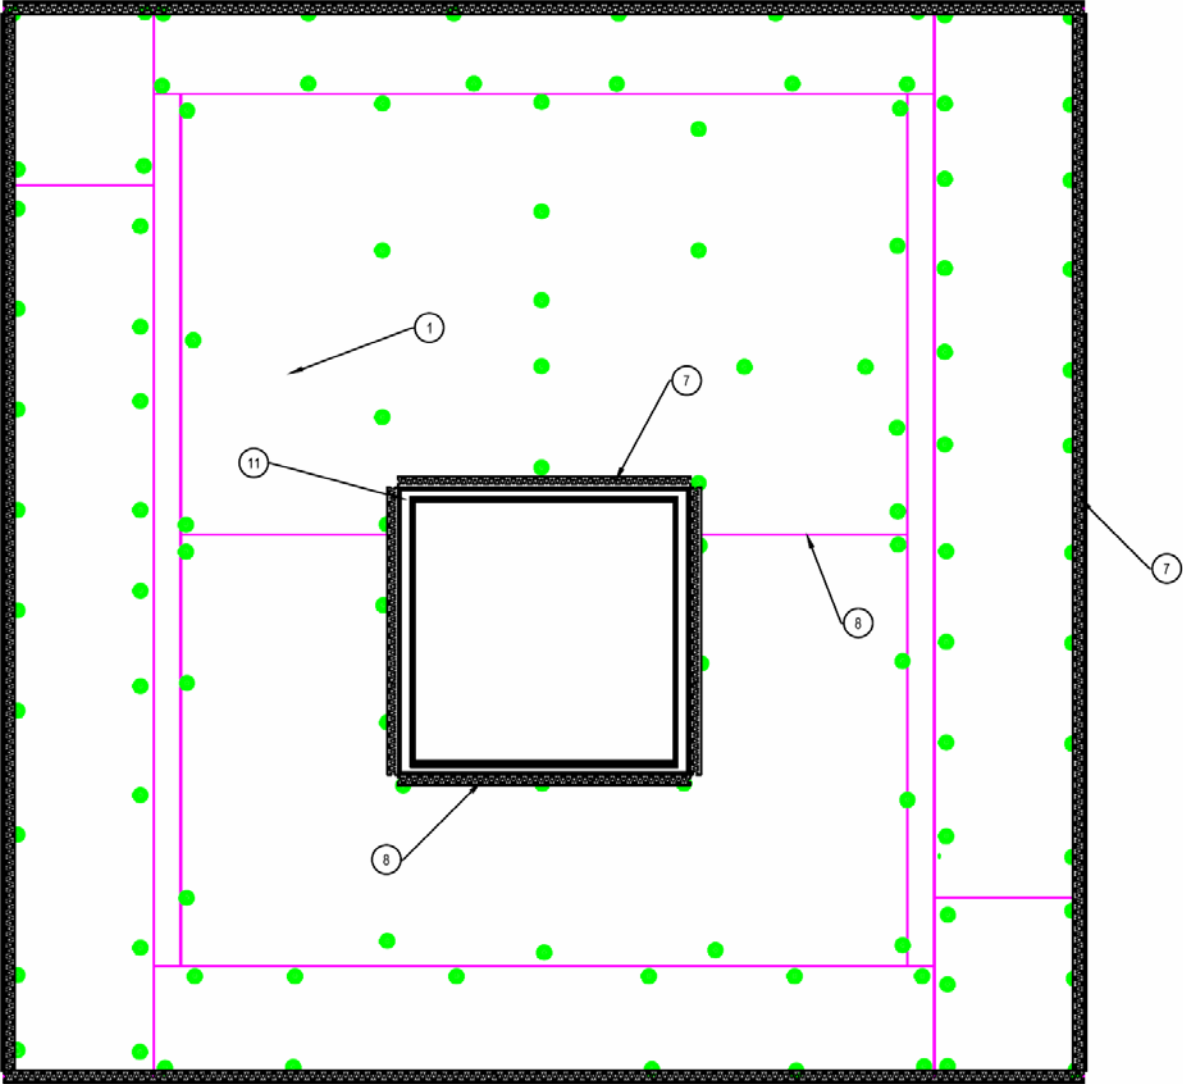
Figure A1.3: Exposed face elevation prior to render application.

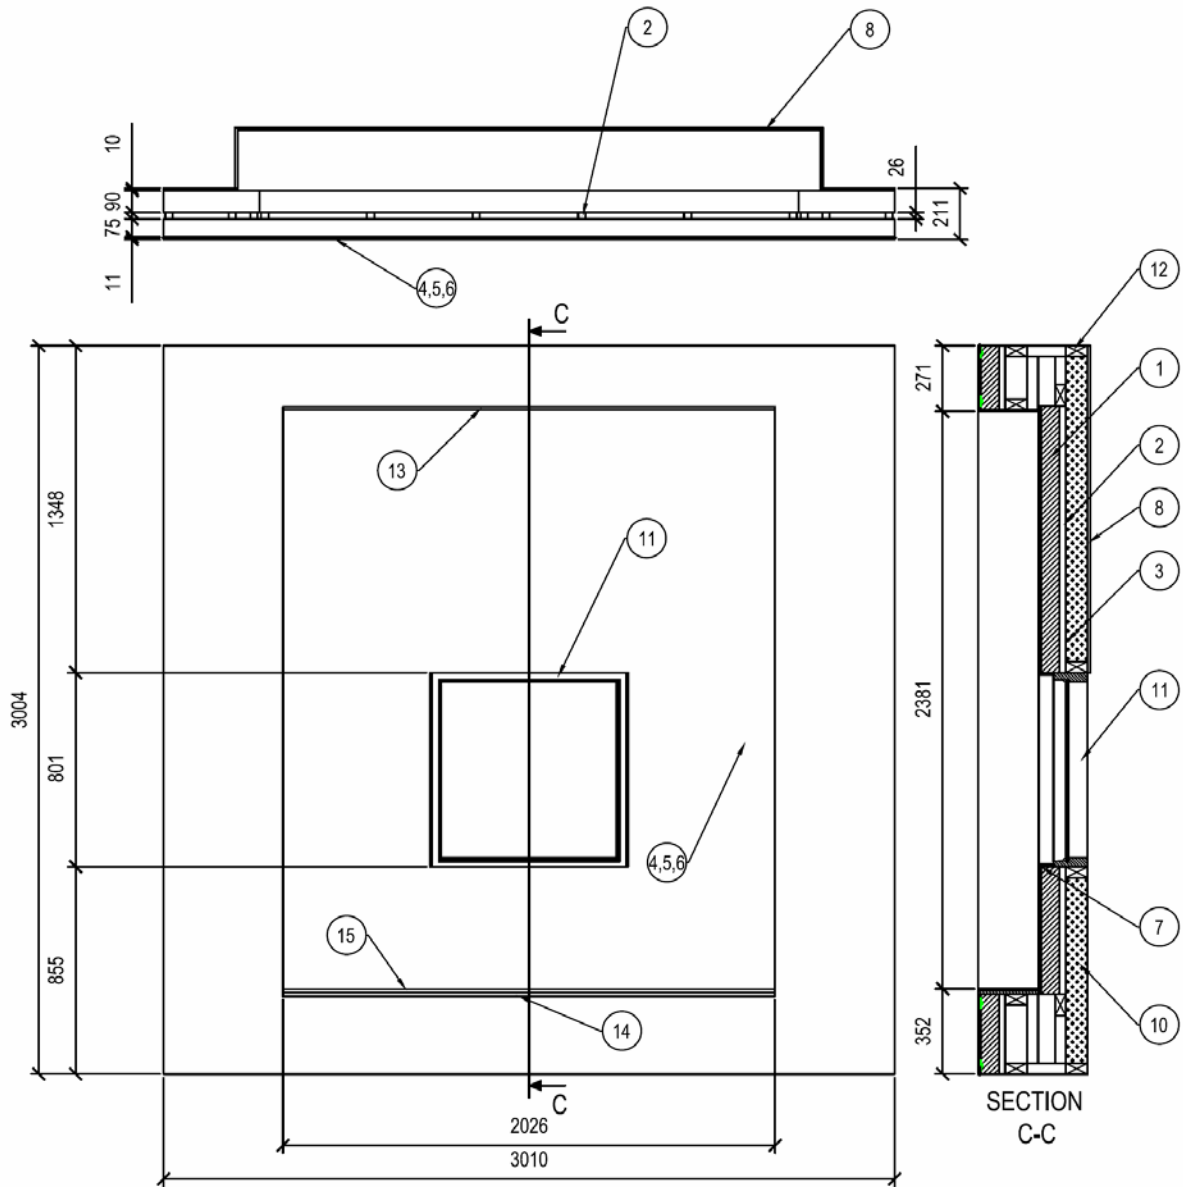
Figure A1.4: Exposed face elevation and section.

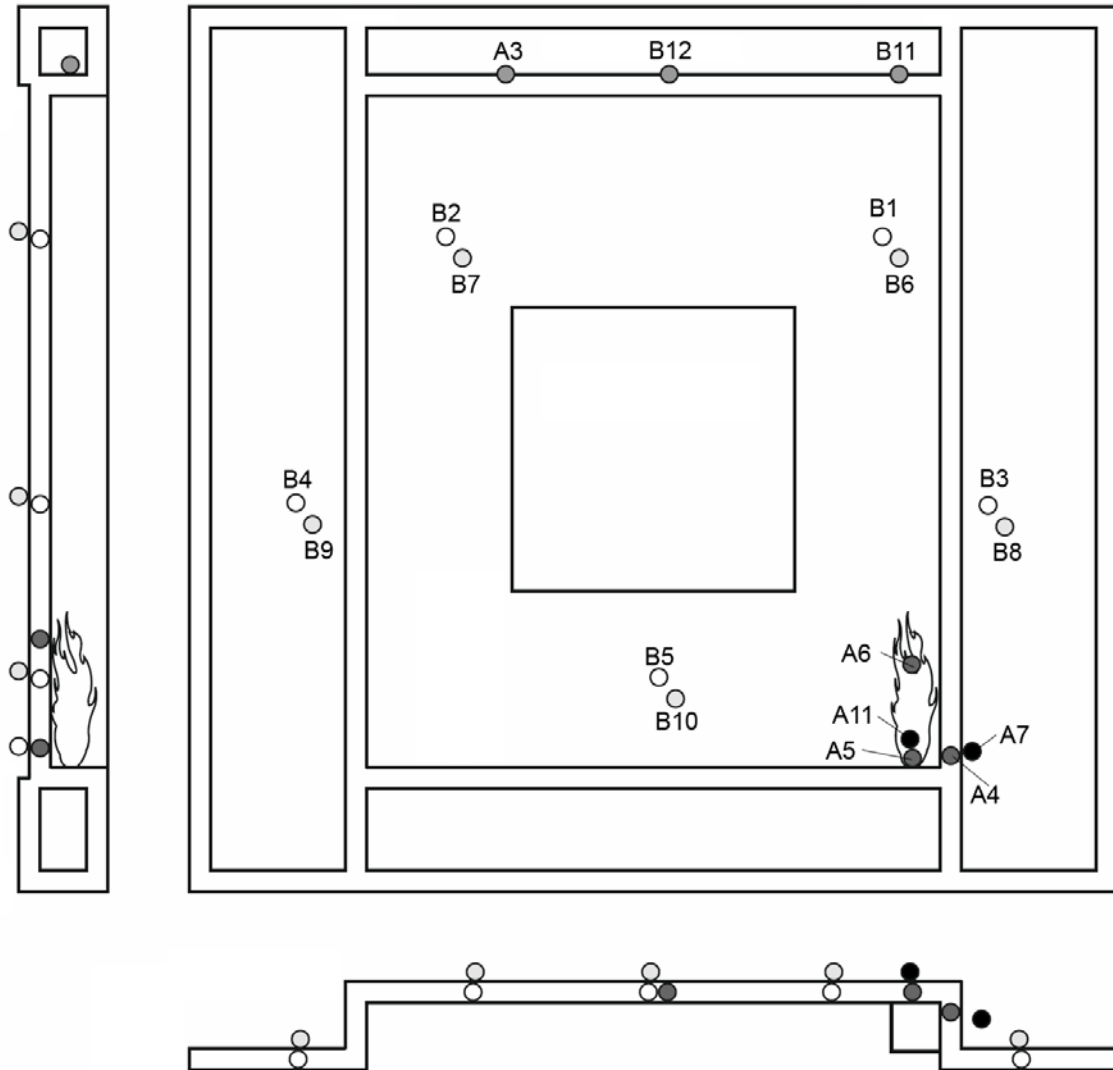
The instrumentation was positioned in accordance with the requirements of AS1530.8.1-2007, Clause 16.3 as summarised below.

Figure A4.1: Thermocouple locations on wall system

Position	T/C	Location			Description
		x	y	z	
Internal Quarter Points	B1	2250	2250	360	Internal cavity surfaces - Mean temperature rise
	B2	750	2250	360	
	B3	2750	1500	110	
	B4	250	1500	110	
	B5	1500	600	360	
External Quarter Points	B6	2250	2250	460	Unexposed face - Mean temperature rise
	B7	750	2250	460	
	B8	2750	1500	210	
	B9	250	1500	210	
	B10	1500	600	460	
Eave	B11	550	2750	125	Internal surface of eaves - Max and mean temperature rise
	B12	1500	2750	125	
	A3	1900	2750	125	
West Crib	A4	2610	380	200	Internal cavity surfaces - Max temperature rise adjacent to West crib
	A5	2450	380	360	
	A6	2450	480	360	Internal cavity surface - Max temperature rise above West crib
	A7	2710	380	200	Unexposed face - Max temperature rise adjacent to West crib
	A11	2450	380	460	
Radiometer Positions	R1	2750	1500	0	Embedded in surface of exposed face.
	R2	1500	1500	0	250mm from exposed side from 20 min to 60 min of test.

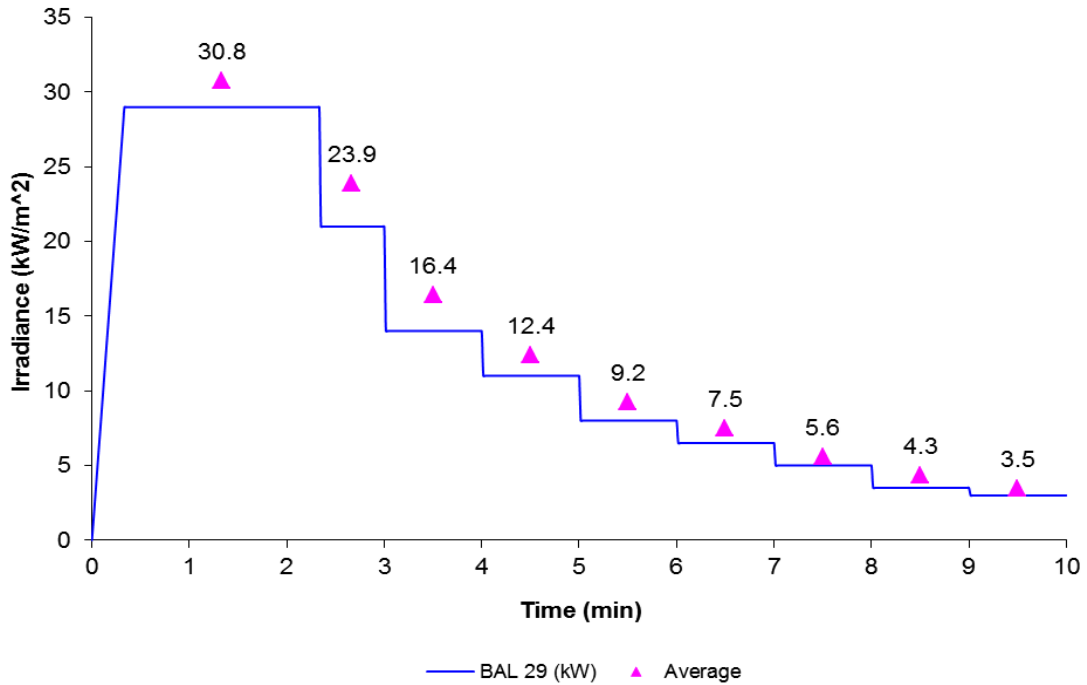
Figure A5.1: Incident heat flux during exposure period.

Radiant heat flux measurements to determine the irradiance transmitted from the exposed face of the specimen were made using a Medtherm Heat Flux Gauges.

During the test, the radiometer in the west wall section remained in place, using values found during an ancillary pre-test calibration to determine the heat flux at the centre of the leading edge of wall.

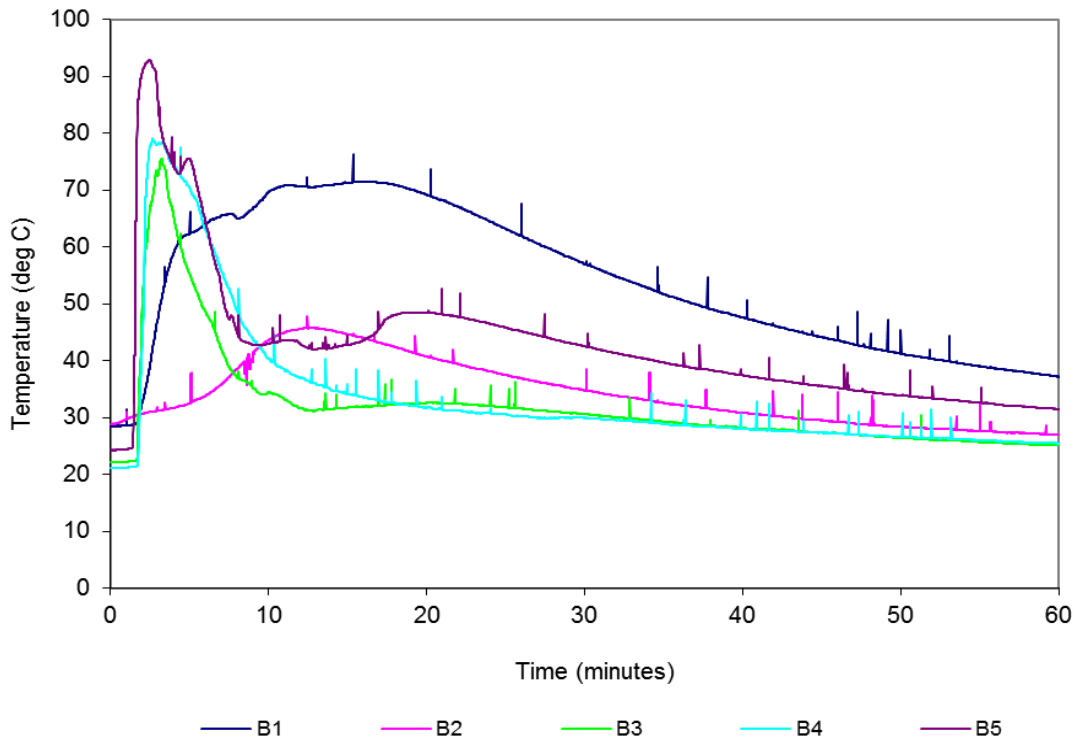
Figure A5.2: Specimen temperatures. Temperatures vs time
Internal quarter points

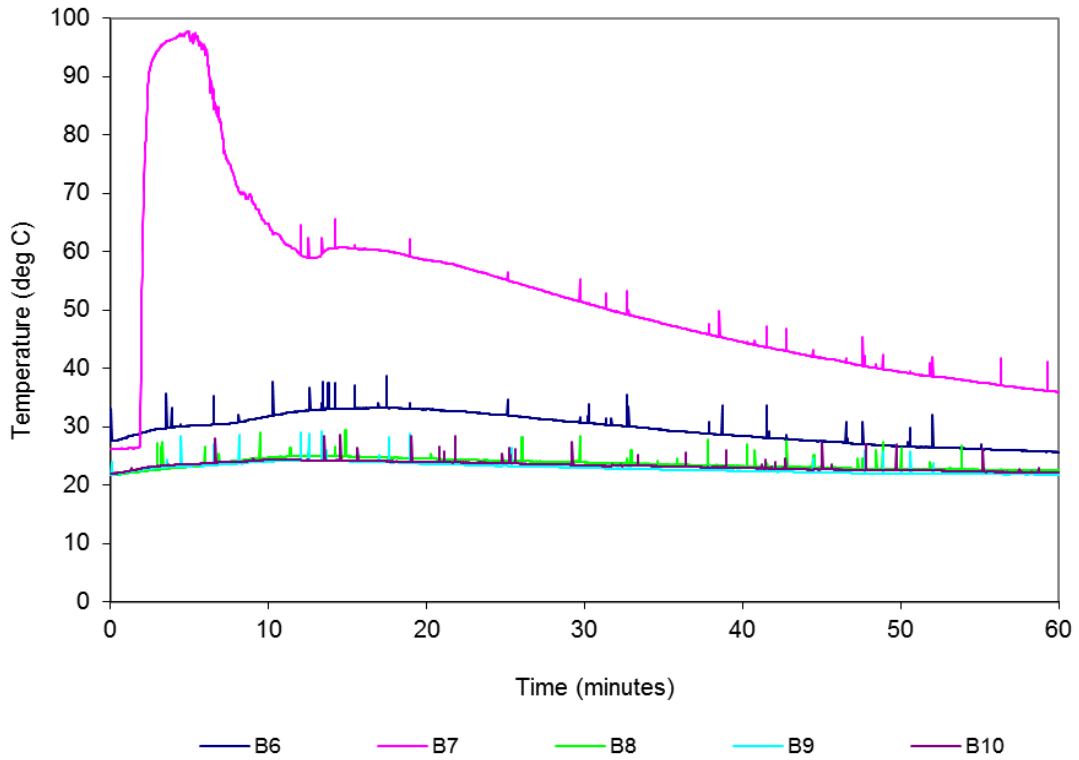
Figure A5.3: Specimen temperatures. Temperatures vs time
Unexposed quarter points

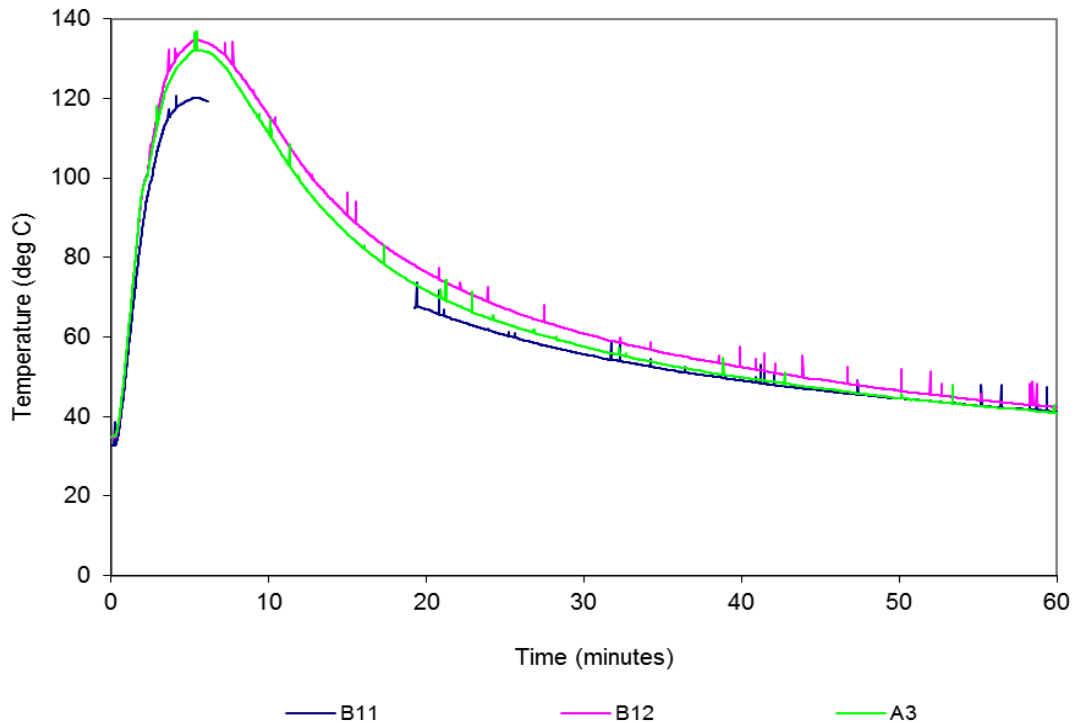
Figure A5.4: Specimen temperatures. Temperatures vs time
Eave mean and maximum
Thermocouple B11 disconnected during the exposure period and
was reconnected when it was deemed safe to do so.

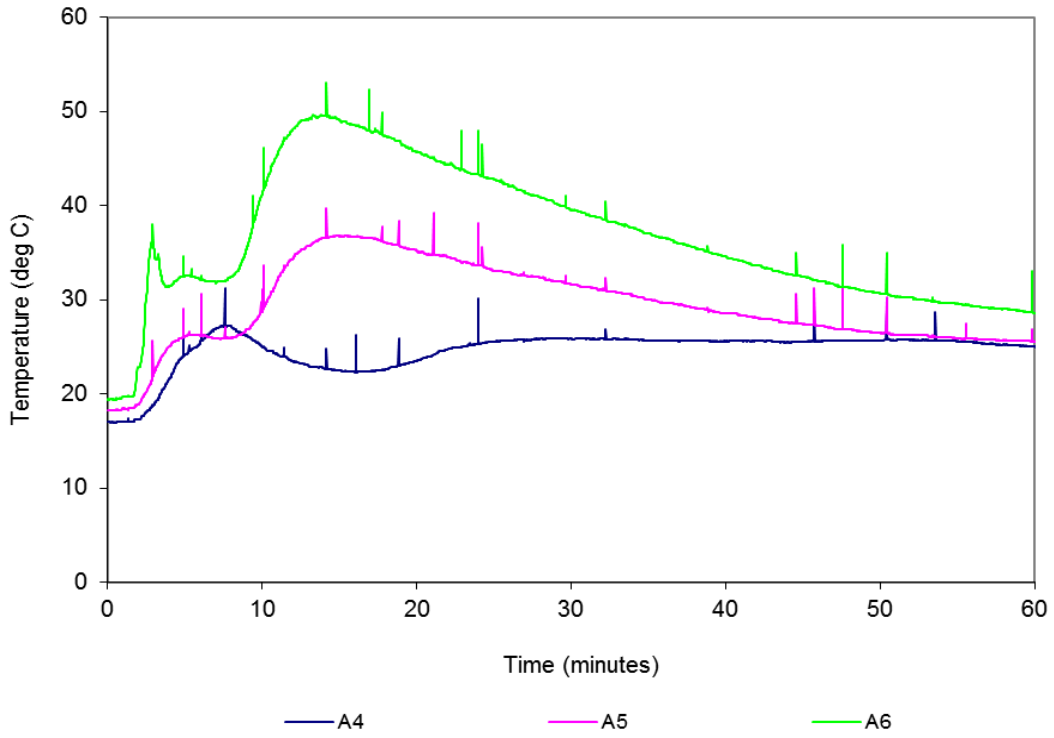
Figure A5.5: Specimen temperatures. Temperatures vs time
Internal around crib

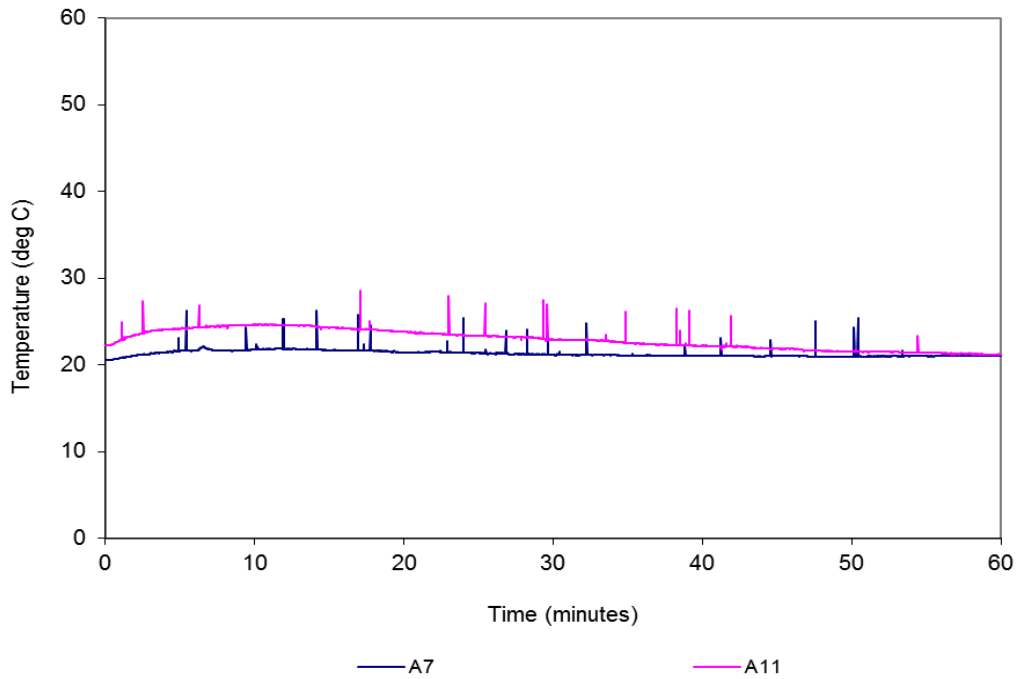
Figure A5.6: Specimen temperatures. Temperatures vs time
Unexposed around crib

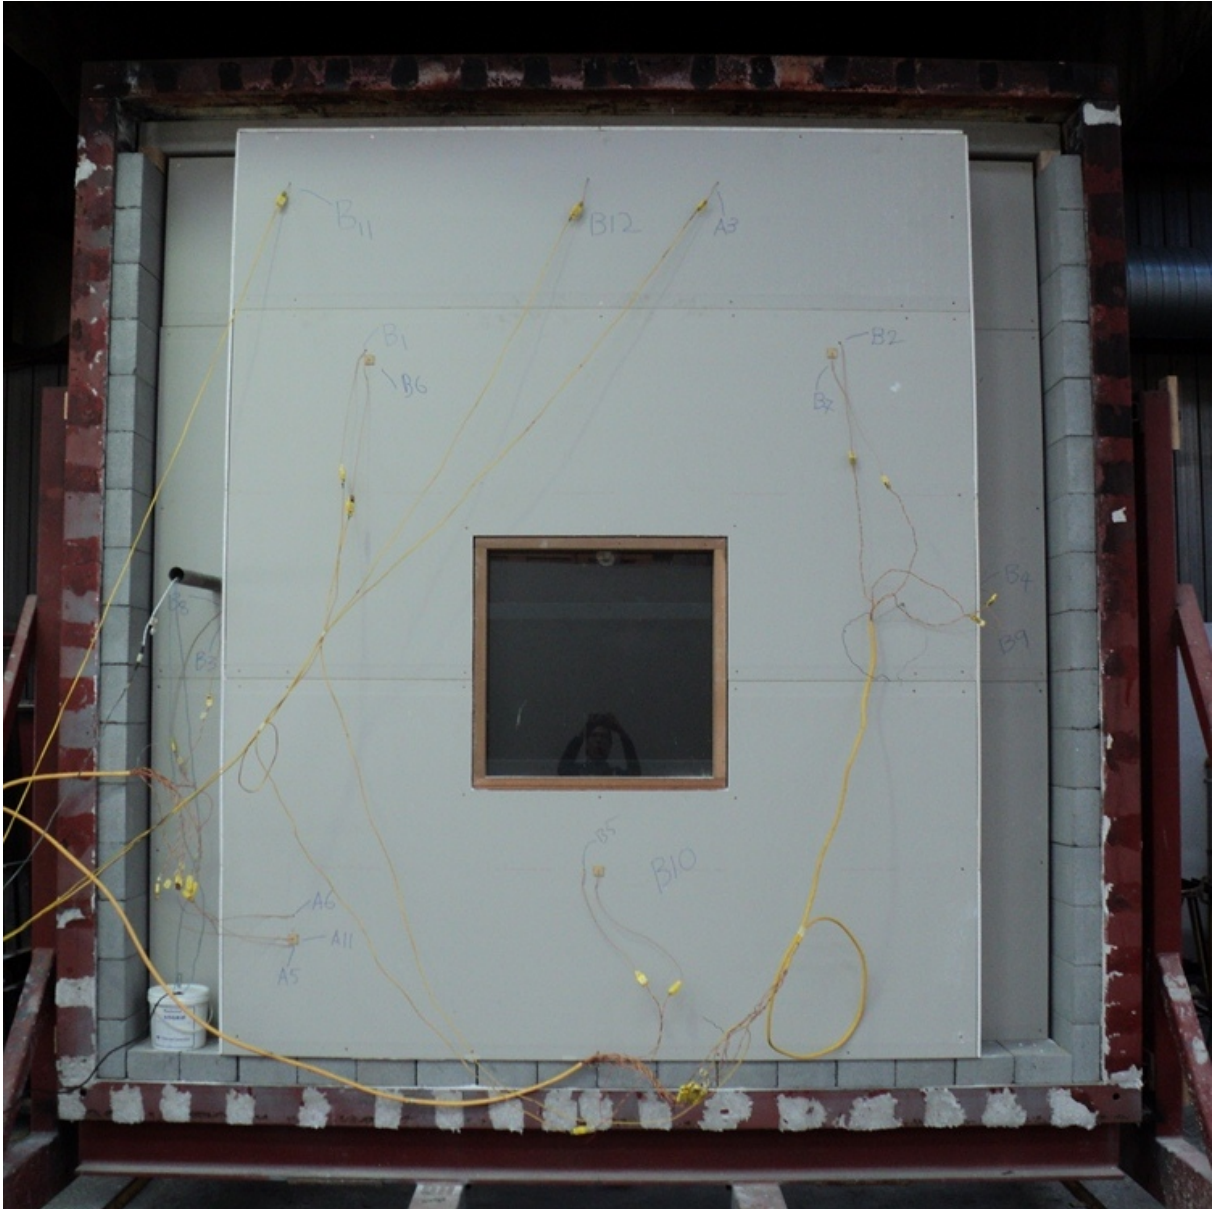
Figure A6.1: Unexposed face of the specimen prior to the test.

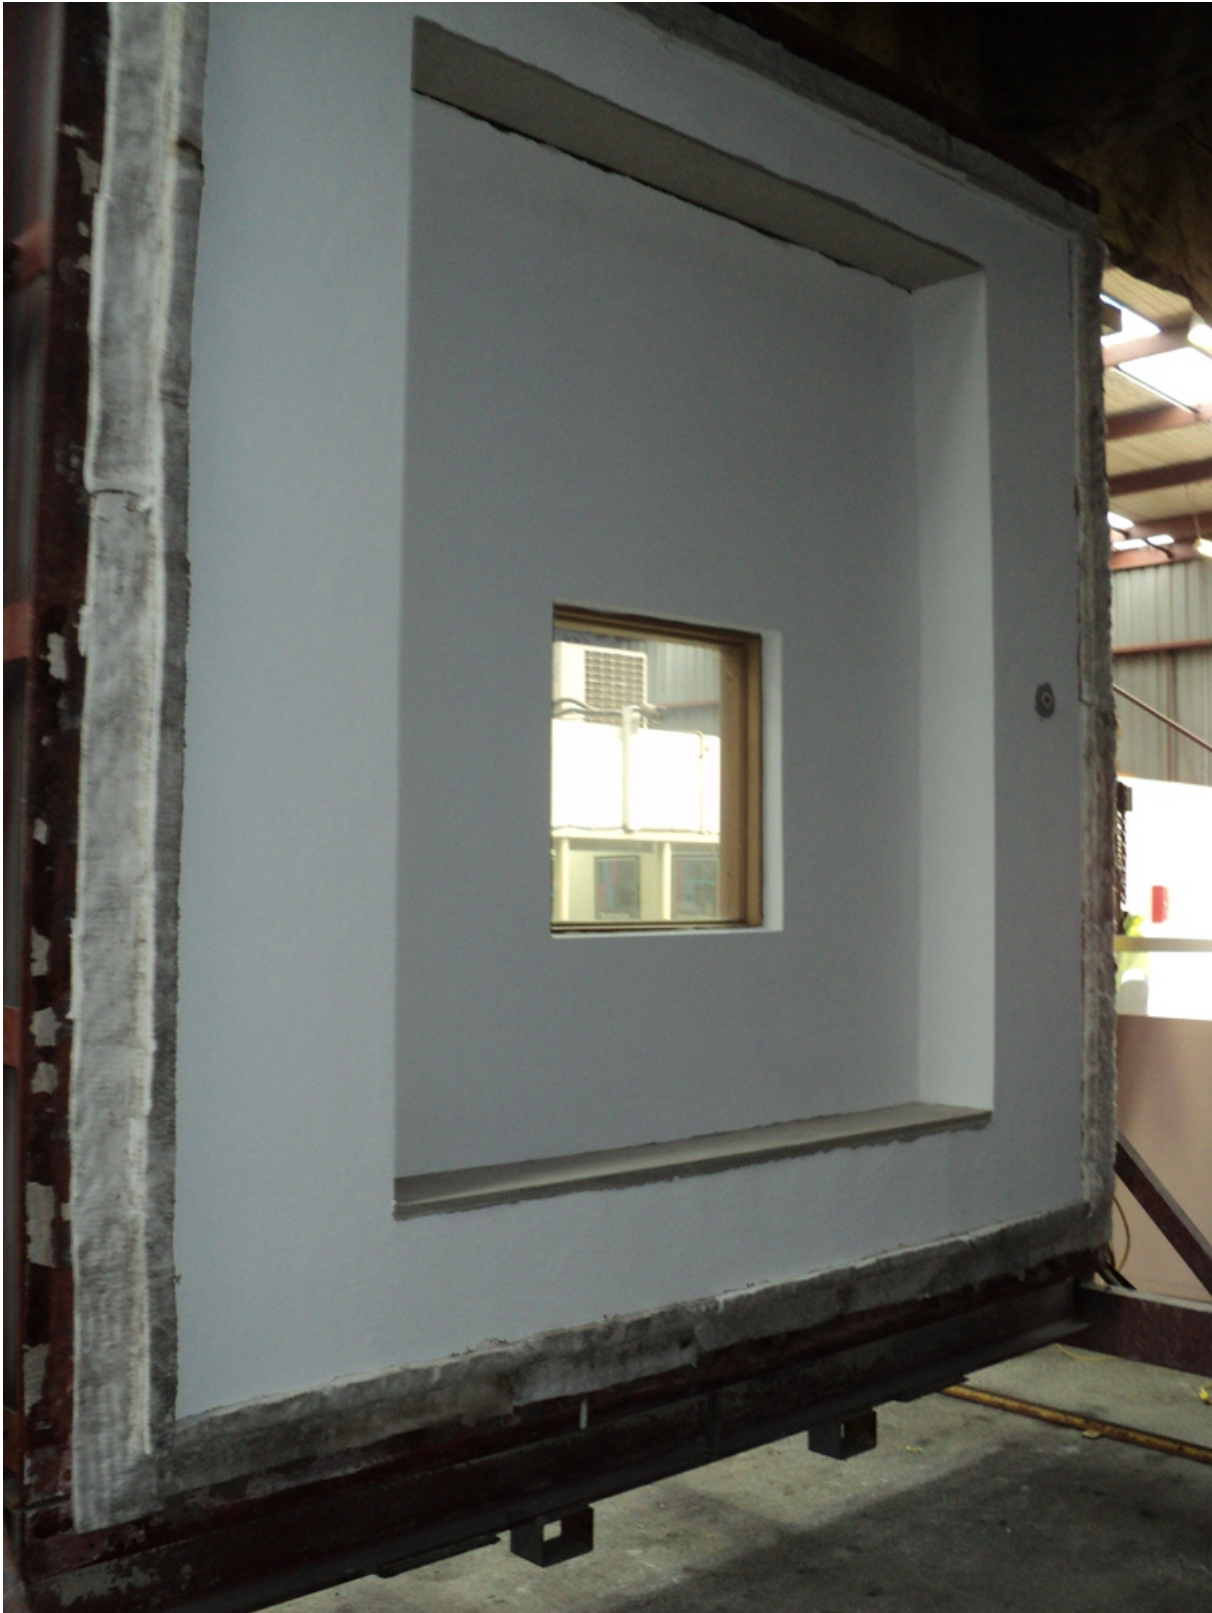
Figure A6.2 Exposed face of the specimen prior to the test.

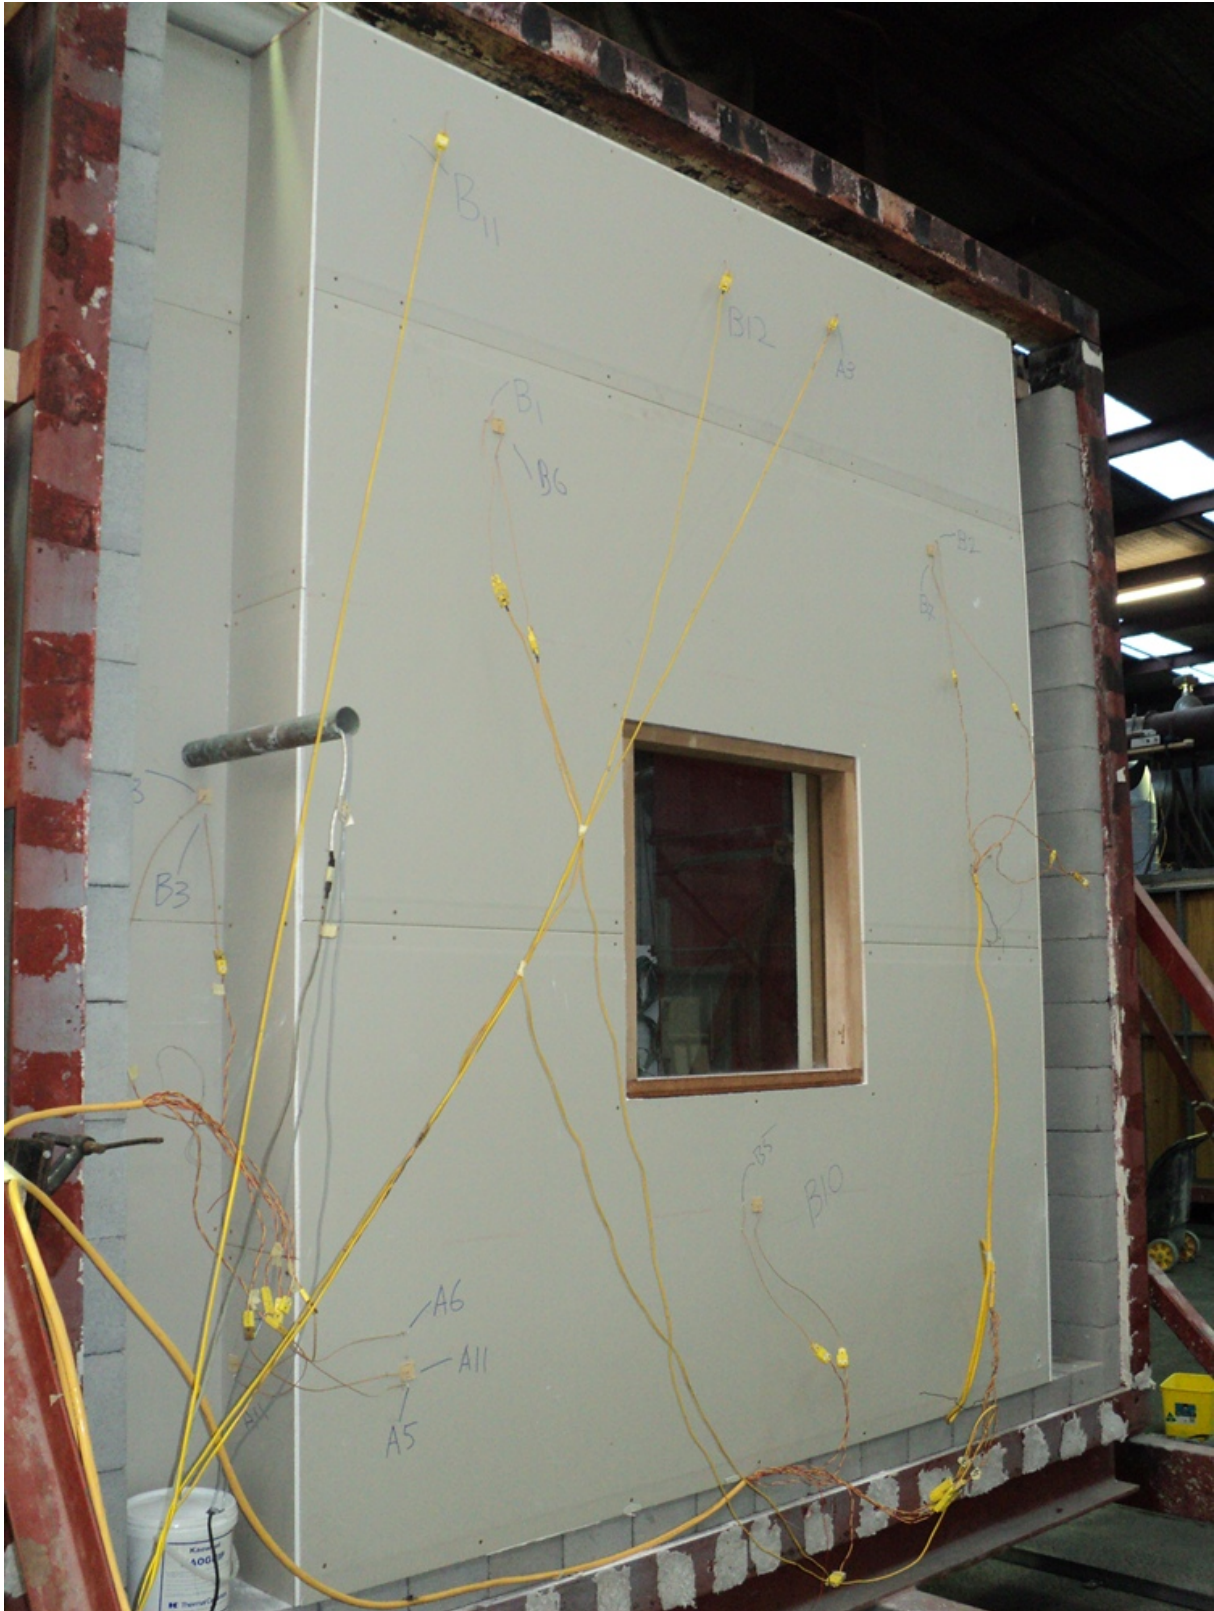
Figure A6.3 Unexposed face of test specimen at completion of test.

Post Test Observation		
Upon removing the unexposed cladding and sarking it was noted that the majority of the EPS had melted away from the render, leaving a cavity. There was no smoking or smouldering behind the render in the wall cavity.

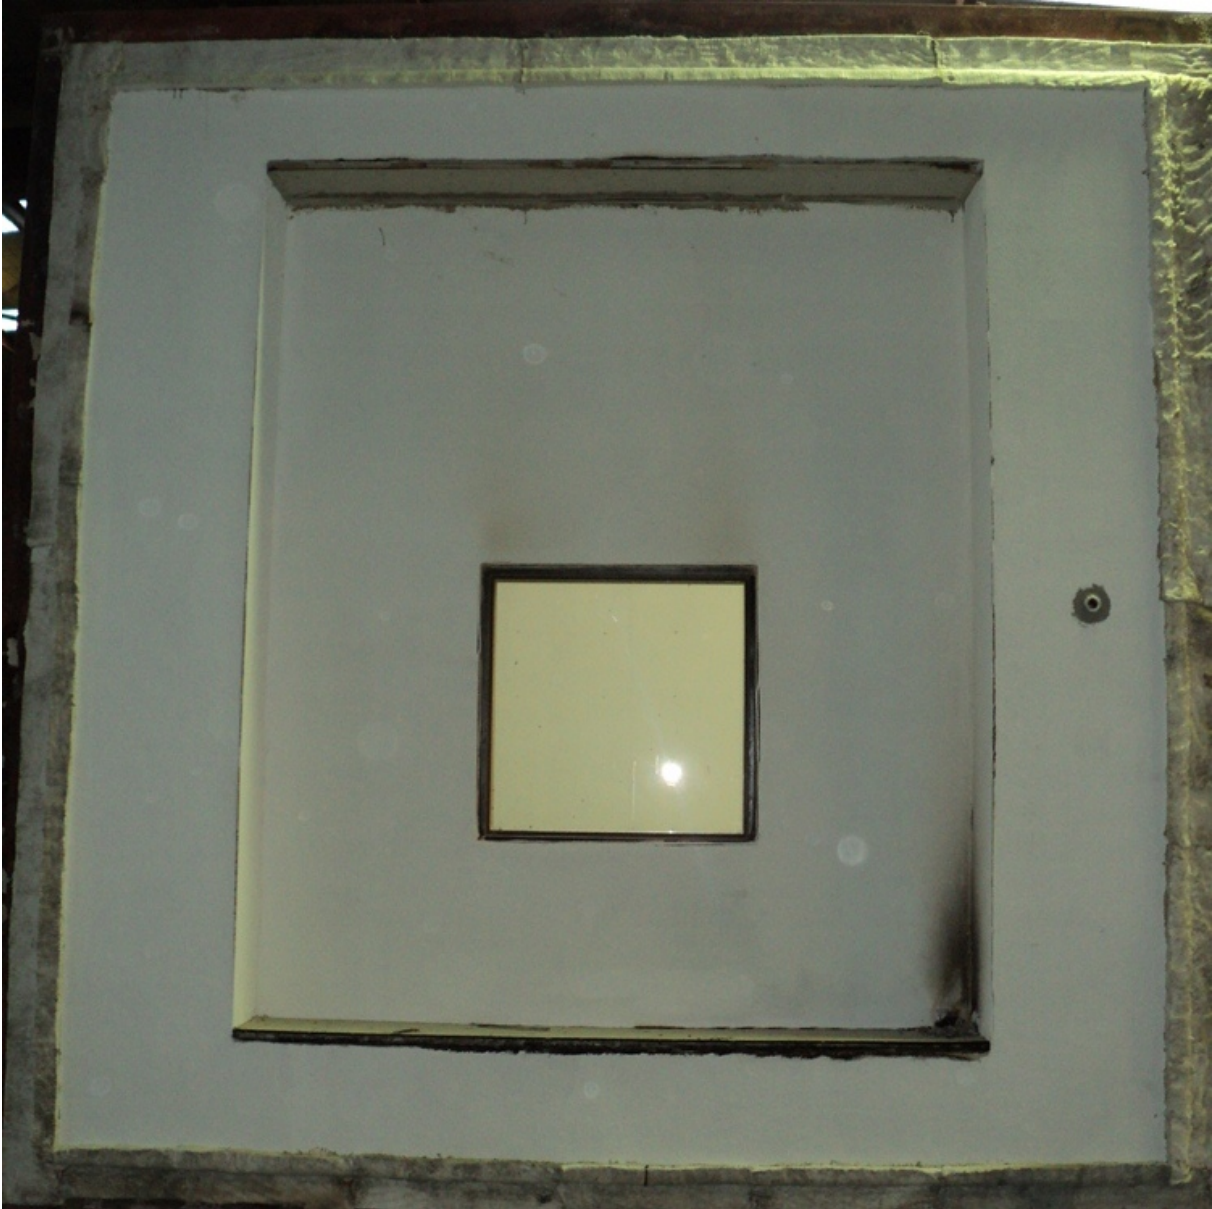
Figure A6.4 Exposed face of test specimen at completion of test.
